Experimental and analytical investigation of dynamic crack patterns in automotive windshield sheets subjected to low velocity impact

Automotive Fluids and Structures Analysis Research Laboratory, School of Automotive Engineering, Iran University of Science and Technology, Tehran 16846-13114, Iran

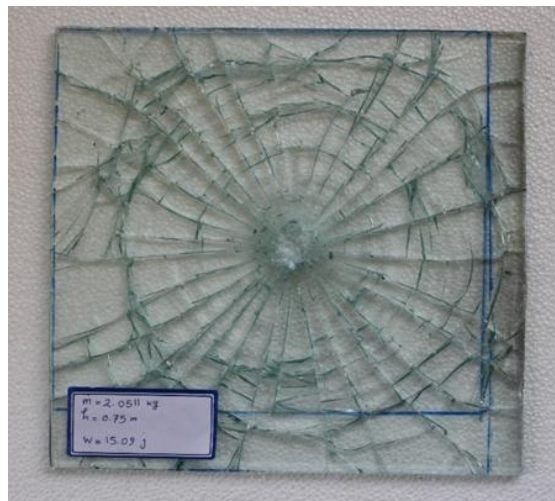
Fig12. .specimen after test code D-B-T-5

Laminated glass specimen after test code D-B-T-5 is shown in Fig.12.

As it is observed from Fig.12, the impact region at the center of specimen (powdering region) is a circle with approximate diameter of 20mm in which cracks density and consequently damage level is higher than the other regions of specimen. The projectile has penetrated to the depth of 4mm of the laminated glass, indeed the upper layer glass has fractured and PVB interlayer has elongated, but no tearing is observed. At the center of test code D-B-T-5 laminated glass, penetration depth has increased in comparison to test codes D-B-T-4 and D-B-T-3. Total number of circumferential cracks of the specimen is 5 which are placed at 47, 70, 80, 90 and 105mm distance from the center. At the vicinity of borders (close to clamping spots), net shaped diagonal cracks are more congested. Cracks have been propagated from the impact surface of laminated glass. At all 4 sides of the specimen, diagonal asymmetrical net shaped cracks have been made. At both upper and lower glass layers, radial cracks converge at the center of the specimen and their divergence increases at larger radiuses. Most of radial cracks have reached the borders of specimen and released their internal impact energy by this way.
